TEST REPORT

Nylon Rail Brackets

Report No: B7404.01-119-19 Report Date: 08/27/12

Architectural Testing was contracted by Fortress Iron Railing & Fence Systems to conduct structural performance tests on their nylon rail brackets in a worst-case 96 in wide by 42 in high guardrail system, comprised of 2x4 cedar rails and pre-galvanized steel balusters. The system was evaluated for the design load requirements of the following building codes:

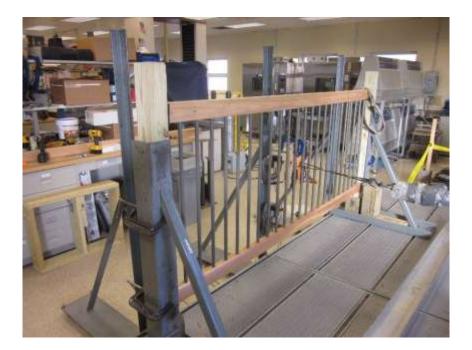
Photo No. 1 In-Fill Load at Center of Three Balusters

Test No. 1 – 03/01/12 Design Load: 50 lb / 1 Square Ft at Center of In-Fill (on Three Balusters)							
	H. I				Displacement (in)		
Load Level	Load (lb)	(min:sec)	End	Mid	End	Net ¹	
Initial Load	10	00:00	0.00	0.00	0.00	0.00	
2.0x Design Load	101	00:09	0.45	0.70	0.67	0.14	
Initial Load	10	02:54	0.00	0.01	0.04	-0.01	
100% Recovery from 2.0 x Design Load							
2.5x Design Load	129	03:35	Achieved Load without Failure

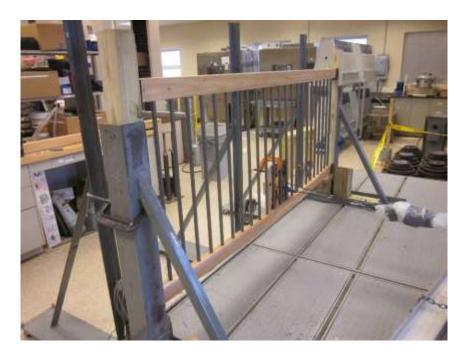
Photo No. 2 In-Fill Load at Bottom of Three Balusters

Test No. 2 – 03/01/12 Design Load: 50 lb / 1 Square Ft at Bottom of In-Fill (on Three Balusters)							
	Test	Test Load (lb) E.T. (min:sec)	Displacement (in)				
Load Level			End	Mid	End	Net ¹	
Initial Load	10	00:00	0.00	0.00	0.00	0.00	
2.0x Design Load	101	00:15	0.07	1.06	0.07	0.99	
Initial Load	10	05:37	-0.01	0.03	0.00	0.03	
97% Recovery from 2.0 x Design Load							
2.5x Design Load	133	06:29	Achieved Load without Failure

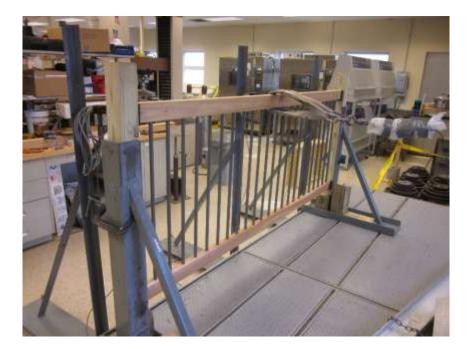
Photo No. 3 Concentrated Load at Midspan of Top Rail

Test No. 3 – 03/01/12 Design Load: 200 lb Concentrated Load at Midspan of Top Rail									
	Test E.T.				Rail Displacement (in)				
Load Level	Load (lb)	(min:sec)	End	Mid	End	Net ¹			
Initial Load	40	00:00	0.00	0.00	0.00	0.00			
2.0x Design Load	400	00:48	0.10	3.86	0.07	3.77			
Initial Load	40	02:51	0.00	0.06	0.00	0.06			
98% Recovery from 2.0 x Design Load									
2.5x Design Load	505	04:00	Achieved Load without Failure

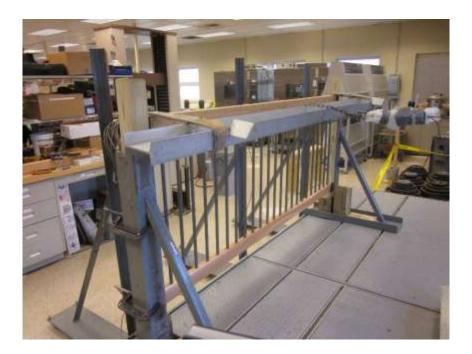
Photo No. 4 Concentrated Load at Both Ends of Top Rail (Brackets)

Test No. 4 – 03/01/12 Design Load: 200 lb Concentrated Load at Ends of Top Rail (Brackets)						
Load Level ¹	Test Load (lb)	E.T. (min:sec)	Rail Displacement (in)			
			Rail End #1	Rail End #2		
Initial Load	79	00:00	0.00	0.00		
(2.0x Design Load) x 2	806	00:41	0.28	0.25		
Initial Load	83	03:12	-0.05	0.04		
84% Recovery from 2.0 x Design Load						
(2.5x Design Load) x 2	1015	4:26	Achieved Load without Failure

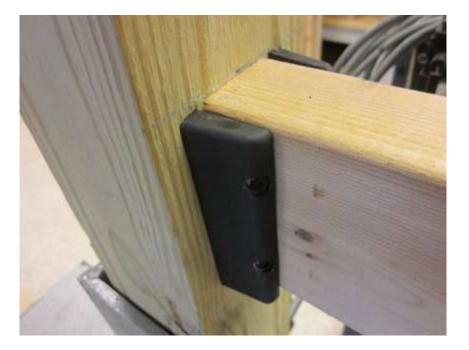
Photo No. 5 Nylon Rail Bracket Installed

Rail Connection Condition: Nylon "drop-in" brackets
